UPPER TUOLUMNE RIVER ECOSYSTEM PROGRAM
**2015–2016 Rim Fire Monitoring in the Hetch
Hetchy Reach of the Upper Tuolumne River**

San Francisco Public Utilities Commission
Natural Resources and Lands Management Division

McBain Associates
980 7th Street
Arcata, CA 95521

June 28, 2017

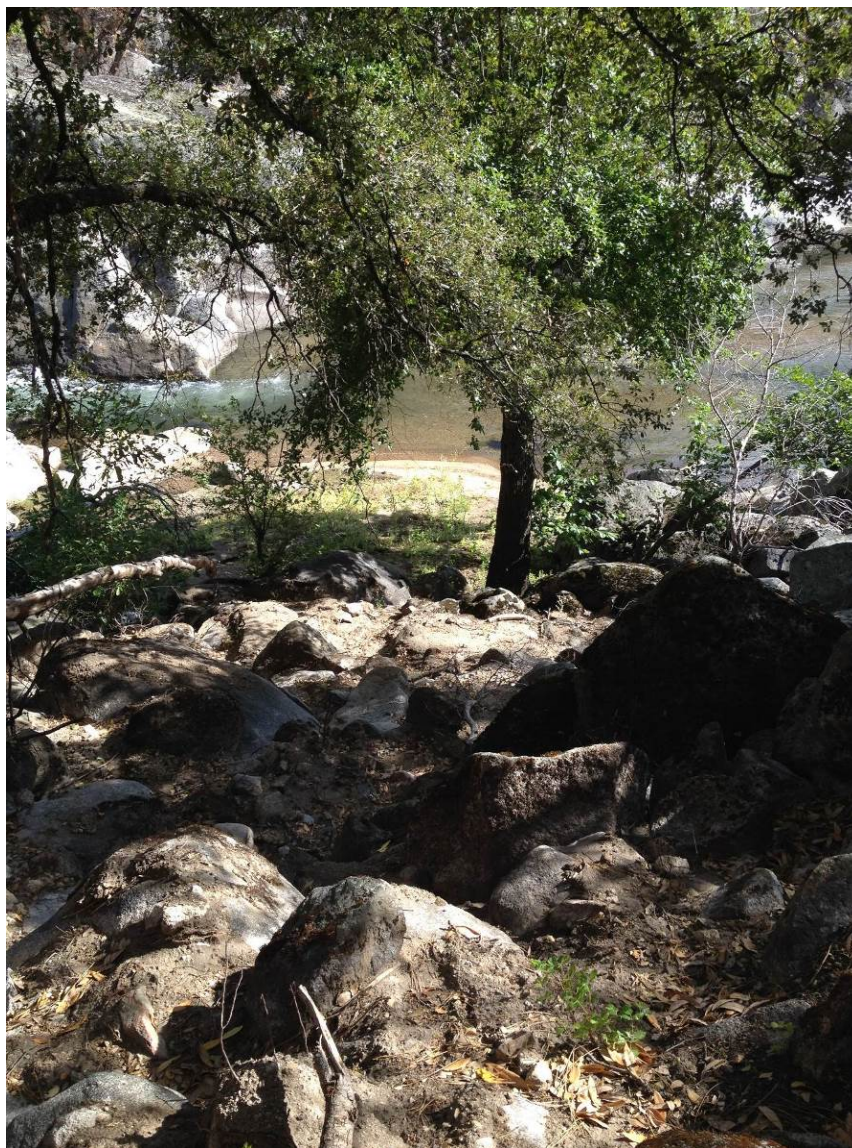
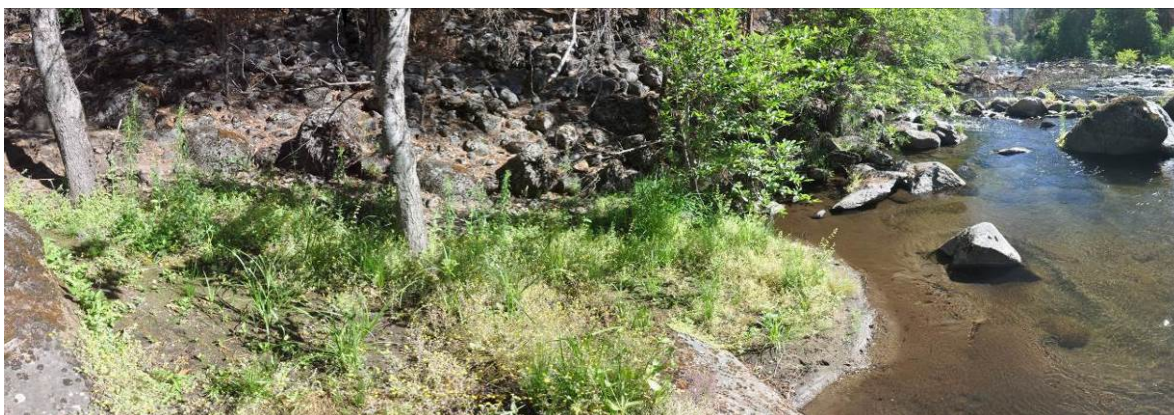
Figure 5. A gully that contributed enough sand to build a bar in the Tuolumne River which was colonized by riparian plants, and subsequently scoured by the 7,200 cfs OSD release in May 2016 (shown in Figure 4). Changes in sand bar area were documented at photopoint 1529+80 upstream of lower Preston Falls. Top photo is from the top of the gully looking down toward the mainstem Tuolumne River in July 2014; bottom photo is from the mainstem Tuolumne River looking upstream where the gully enters.

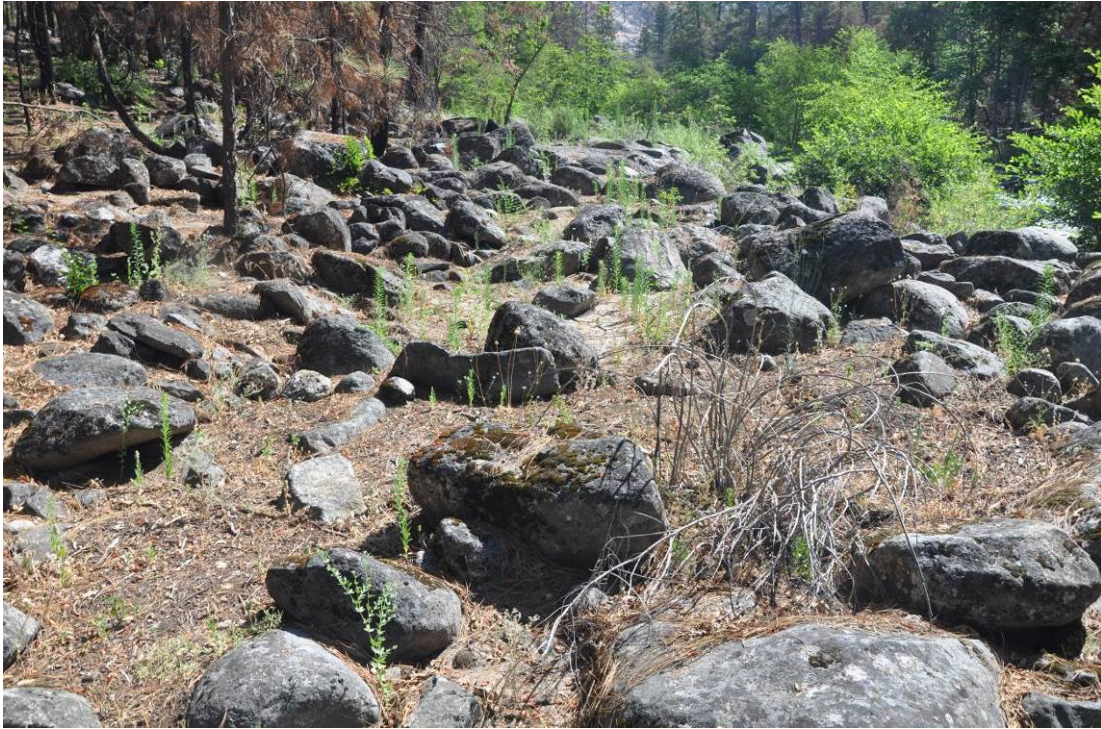
Figure 6. Boulder bar at Albino Pool station 1528+50 in July 2014, showing the interstitial spaces between boulders filled in with fine sediments.

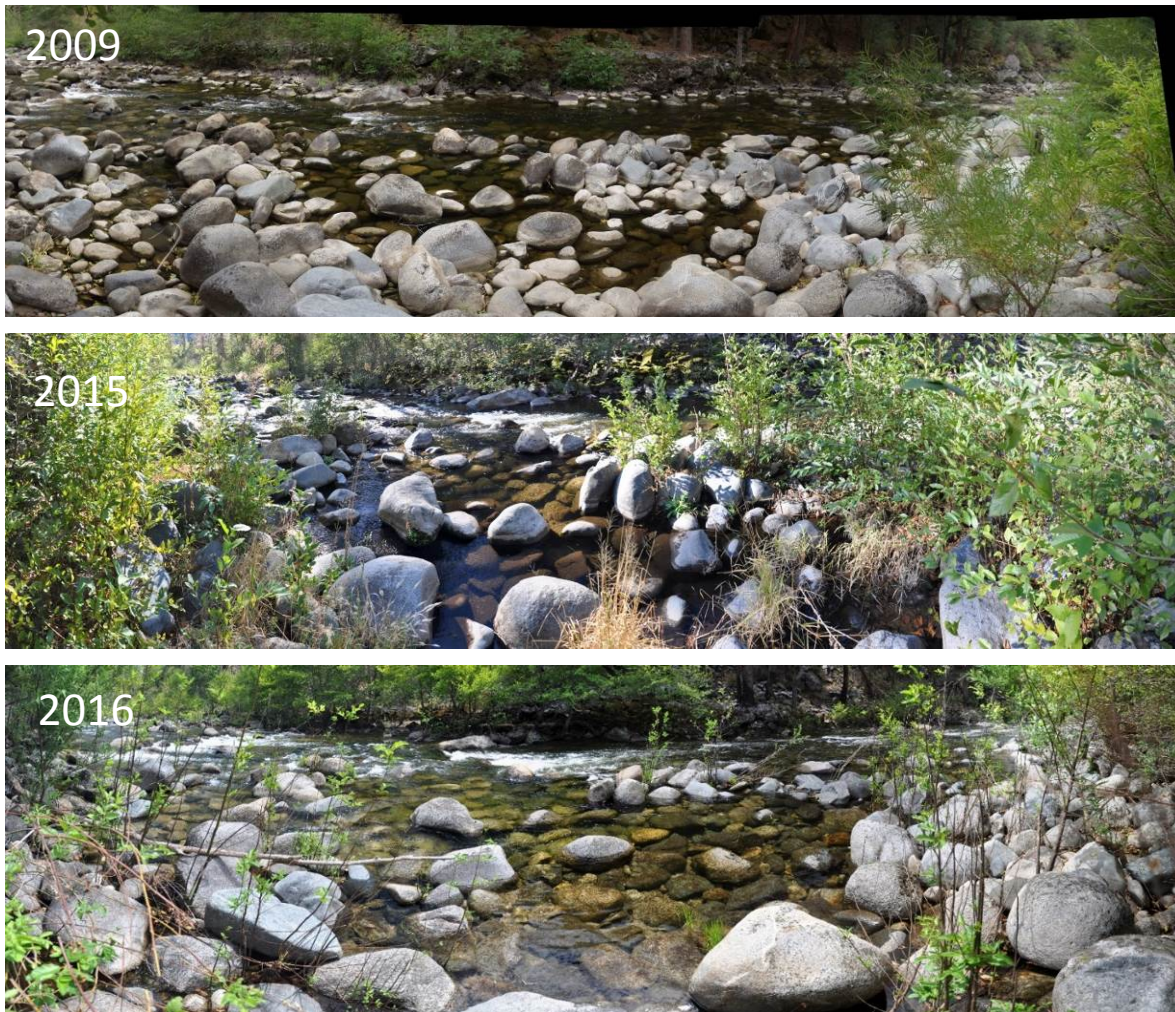
Figure 9. Photopoint 1469+50 comparison between May 2009 and July 2016 at the downstream end of the Early Intake Boulder Garden Reach. No woody plants can be seen the wetted channel area in 2009. By October 2015, alders had encroached the wetted channel and established within the accumulating sand/silt. The 7,200 cfs streamflow in May 2016 scoured most of the woody plants from the wetted channel.

Photo monitoring was used to document the colonization and growth of woody riparian plants rooted in interstitial spaces of larger grain sizes (large cobbles and boulders). In-channel boulder pockets were identified as being prone to the permanent establishment of woody riparian vegetation if flood peaks did not exceed 5,000 cfs for three years or more. Fine sediment deposited in boulder pockets created conditions where seeds could germinate and establish (Figure 9).

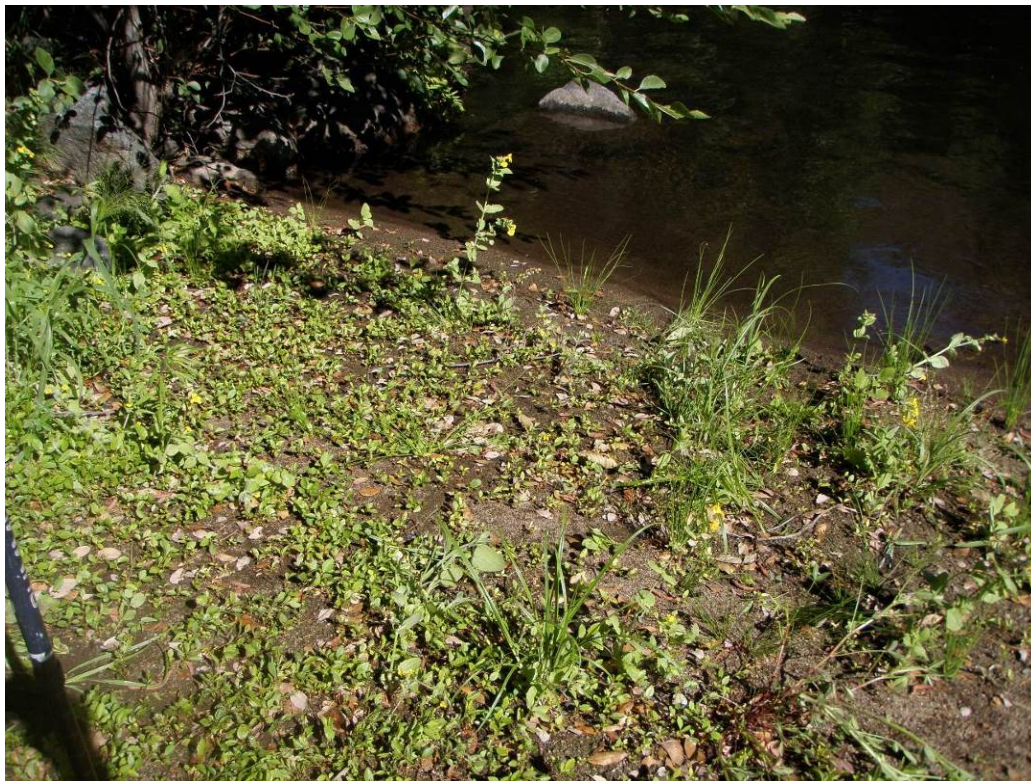
Figure 14. Freshly deposited sand bar colonized with riparian seedlings in July 2014 at station 1529+30.

Overall observations downstream of Preston Falls suggested that alder seedling recruitment has been particularly high since 2013 (Figure 14). Riparian plants rapidly colonized eddy deposits and fine sediment bars at delivery points, presumably due to their long exposure above water during dry years, readily available soil moisture, and fine textured sediment (Figure 4, Figure 5). Seeds have also germinated in fine organic debris caught on the woody debris and on shoreline silts (Figure 15).

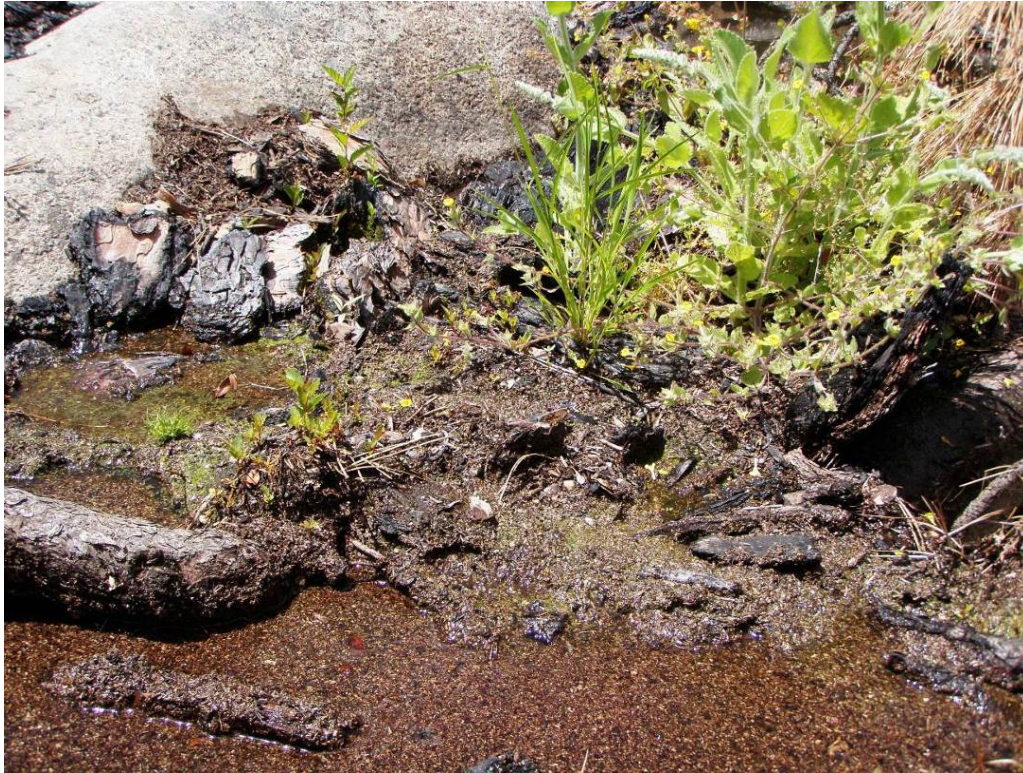
Figure 15. Floating alder seeds (foreground) were deposited and germinated in fine silts/sand and organic debris deposited on the shoreline July 2014.

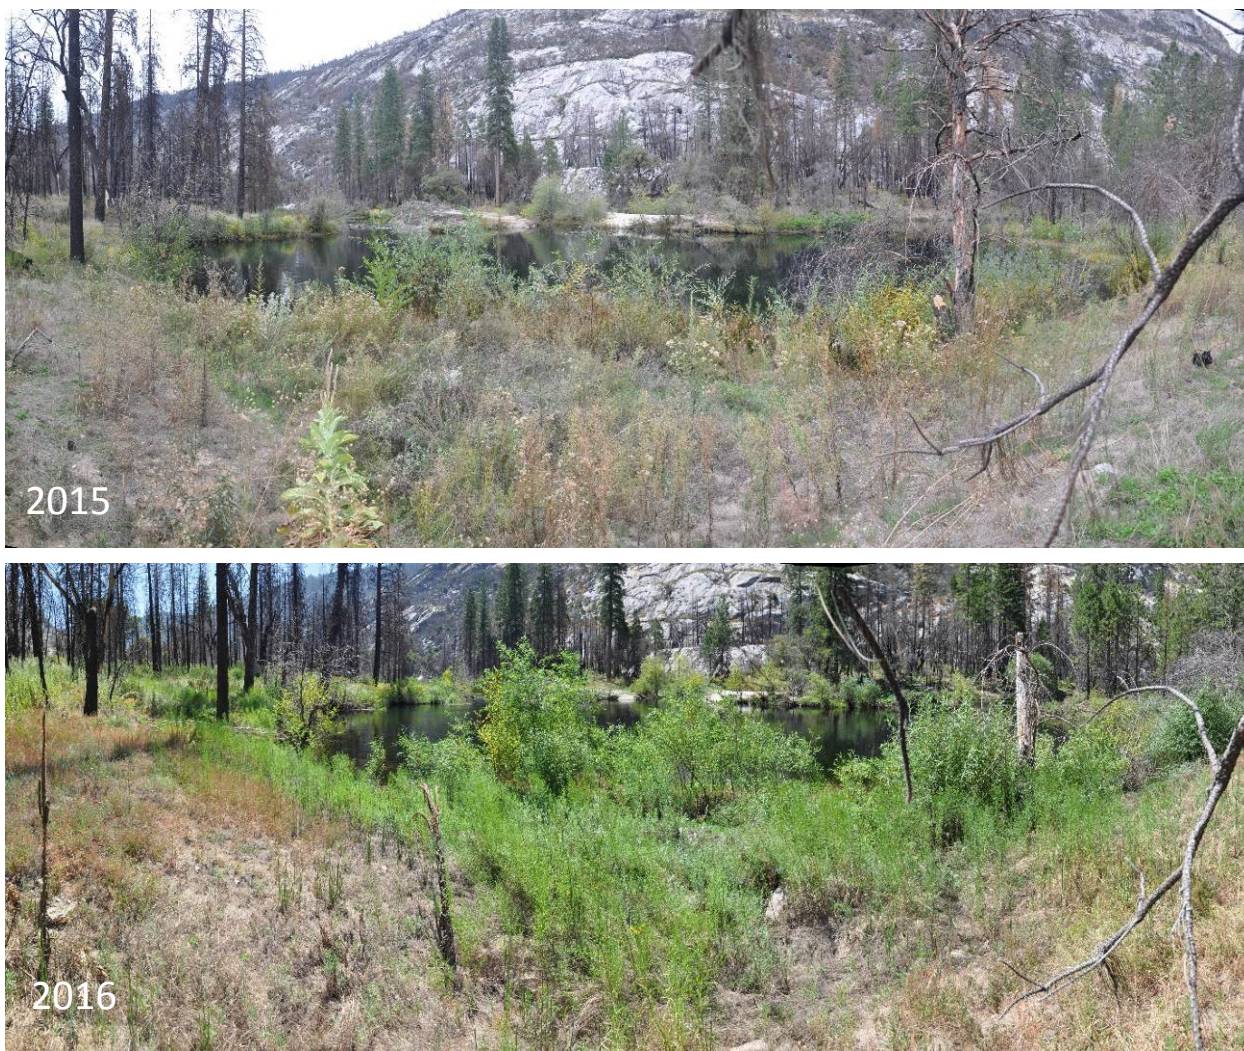
Figure 17. Photopoint 1623+00 comparison between October 2015 and July 2016 at Fireplace Bar within the Fireplace site. The 7,200 cfs OSD release in May 2016 did not change the bar area and vegetative cover substantially. The channel is wide at Fireplace Pool, and velocities and scour along the pool margin during the 7,200 cfs streamflow event would have been low, which likely protected the bar from any significant scour during high flows.

A sand delta formed along the right bank of Fireplace pool and is located within the Fireplace site. The sand delta was observed in November 2013 and had grown larger by July 2014 (Figure 17). Cross section 1623+00 at the fireplace site bisects a large pool, Fireplace Bar and the sand delta. The 7,200 cfs streamflow did not change the bar area and vegetative cover substantially. The channel is wide at Fireplace Pool, and velocities and scour along the pool margin during the May 2016 event would have been low, which likely protected the bar from any significant scour during high flows.

- Quantify the Fireplace Pool area change over time using air photos, and/or re-survey the Fireplace Pool cross section. The bar area was estimated to be 500 ft² in 2015 and 300–500 ft² in 2016.

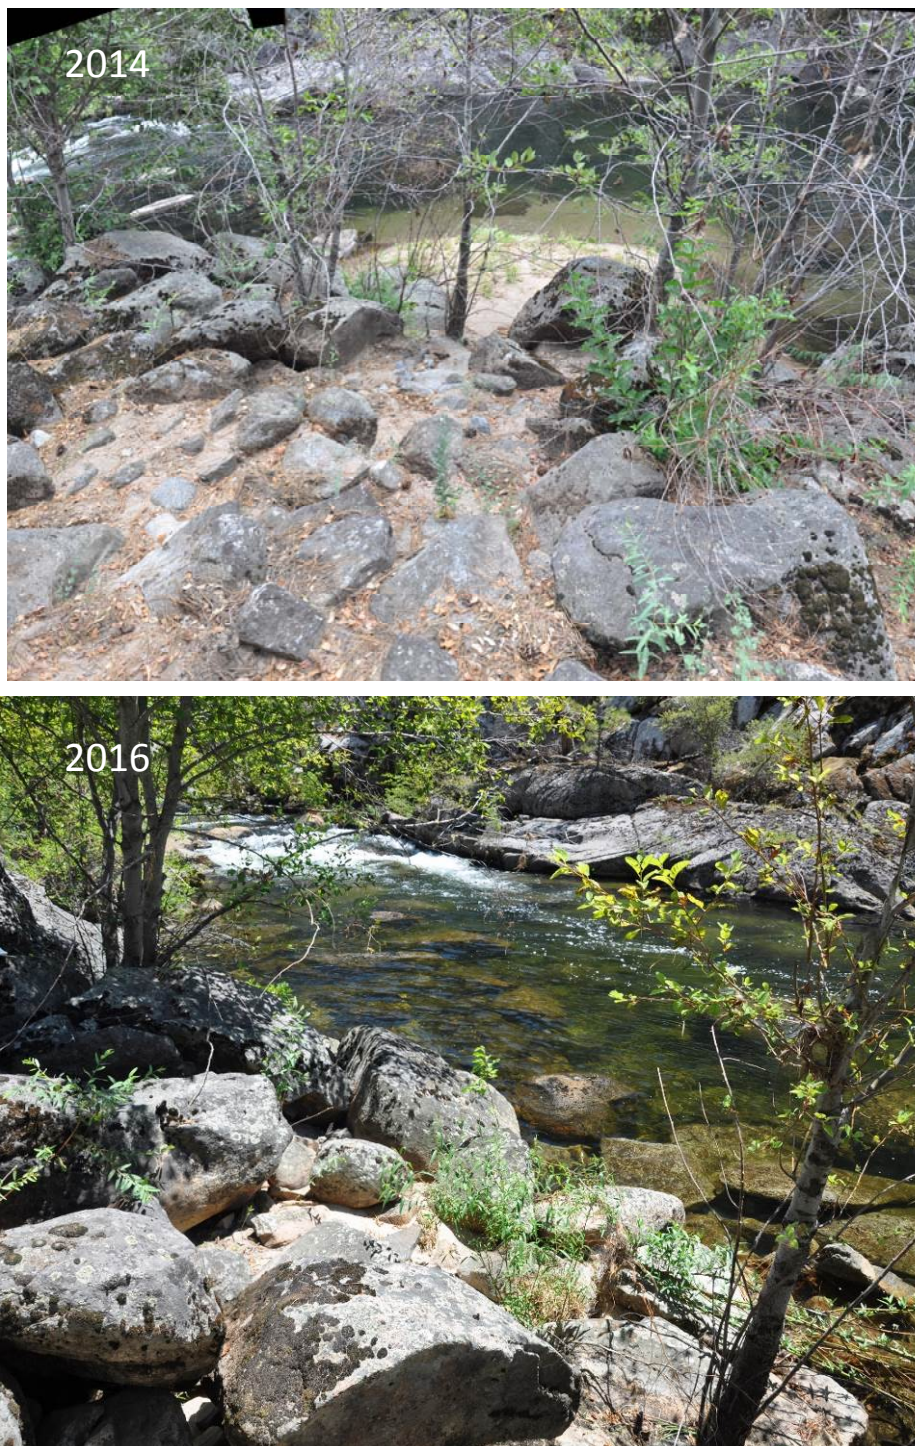
Figure 18. Photopoint 1595+50 comparison between July 2014 and July 2016 at the bar above Mystery Bar, upstream of the Mystery Bar site. The bar was initially observed during 2014 field reconnaissance. In October 2015, the bar was hardly discernable, and was initially thought to be eroded. However, further inspection revealed it was heavily vegetated. The 7,200 cfs OSD release in May 2016 completely scoured the bar and removed all plants that were sampled in October 2015.

This bar is located on the right bank of a broad pool upstream of Mystery Bar at longitudinal station 1595+50. A sand delta from a hillslope gully forms this bar on the right bank. The bar was initially observed during 2014 field reconnaissance. In October 2015, the bar was hardly discernable, and was initially thought to be eroded. However, further inspection revealed it was heavily vegetated (Figure 18). The 7,200 cfs streamflow completely scoured the bar and removed all plants that were sampled in October 2015. The bar area was 150 ft² in 2015 and 0 ft² in 2016.

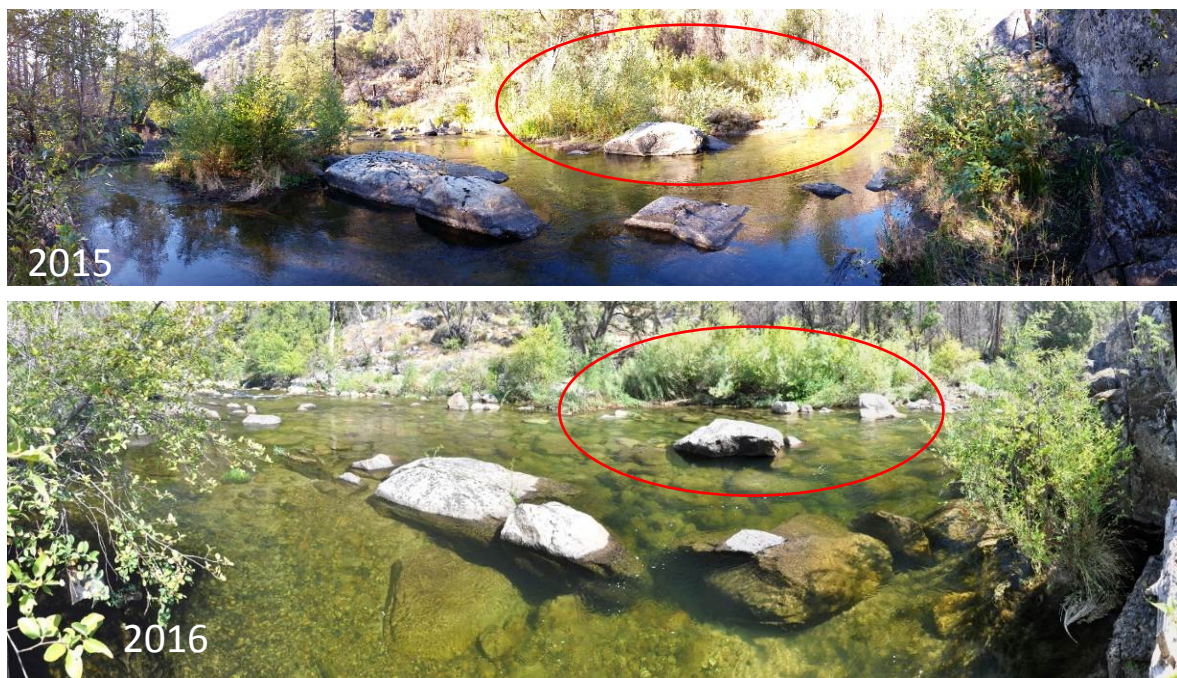
Figure 19. Photopoint 1585+80 comparison between 2015 and 2016 at Fire Bar downstream of the Mystery Bar site. The 7,200 cfs OSD release in May 2016 eroded the bar and establishing plants to the edge of existing mature vegetation. After the spring high flows, some 3 year-old alders remained in the zone of previously established plants, but the bar itself was gone.

Fire Bar was the largest of the sand bars sampled and is located at longitudinal station 1585+80. Sediment delivered to the river had formed a large sand bar that had been colonized by riparian vegetation (Figure 19). The 7,200 cfs streamflow scoured the bar and establishing plants to the edge of existing mature vegetation. The bar area was not noted in 2015 and was 0 ft² in 2016.

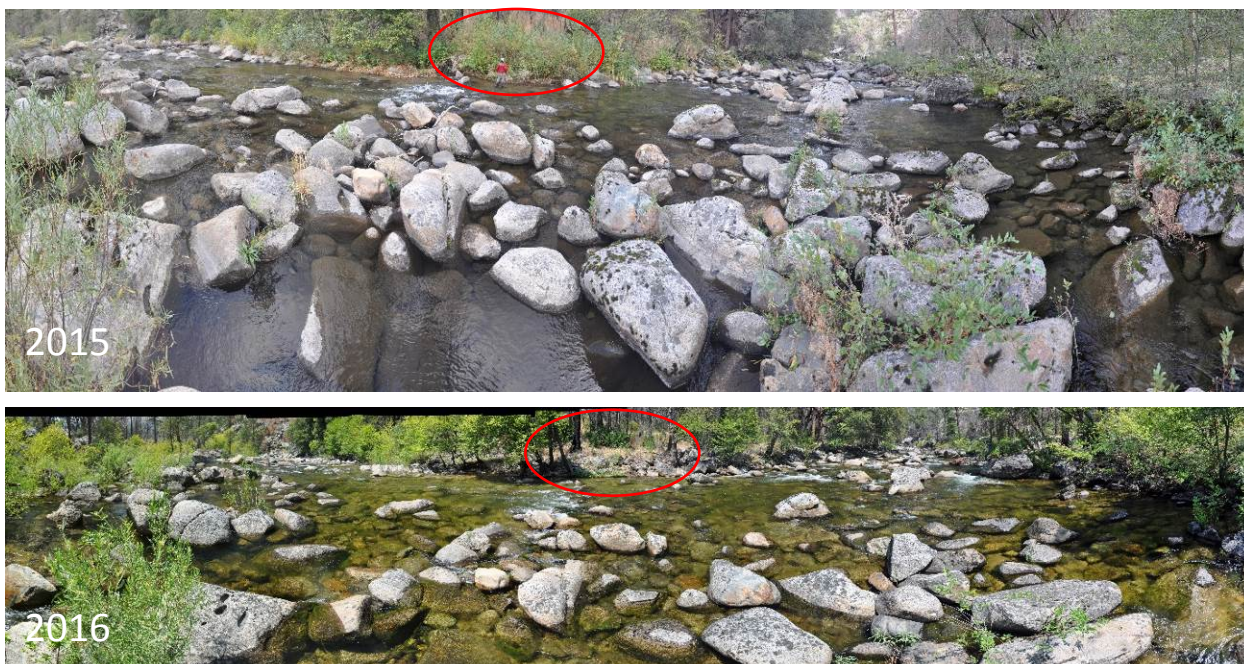
Figure 20. Photopoint 1552+25 (left bank) comparison between 2015 and 2016 at Ent Bar downstream of Lower Preston Falls. The 7,200 cfs OSD release in May 2016 completely eroded the bar shown inside the red oval and removed all plants that were sampled in October 2015.

Ent Bar was on the right bank at the upstream end of the long riffle captured in photopoint 1548+80 (Figure 20). A sand delta from a hillslope gully forms the bar. The river channel around Ent Bar was very complex with a slack water area on the left bank. One hundred feet upstream of Ent Bar, a large 28-inch DBH alder (the “Ent tree”) grows on the right bank. The alder is old enough to have established before the Canyon Tunnel was completed in 1967. The 7,200 cfs streamflow completely scoured the bar and removed all plants that were sampled in October 2015. The bar area was 150 ft² in 2015 and 0 ft² in 2016. After the spring high flows, the Ent tree and other mature alder trees, and some 3-year-old alders remained in the zone of previously established plants, but the bar itself was gone.

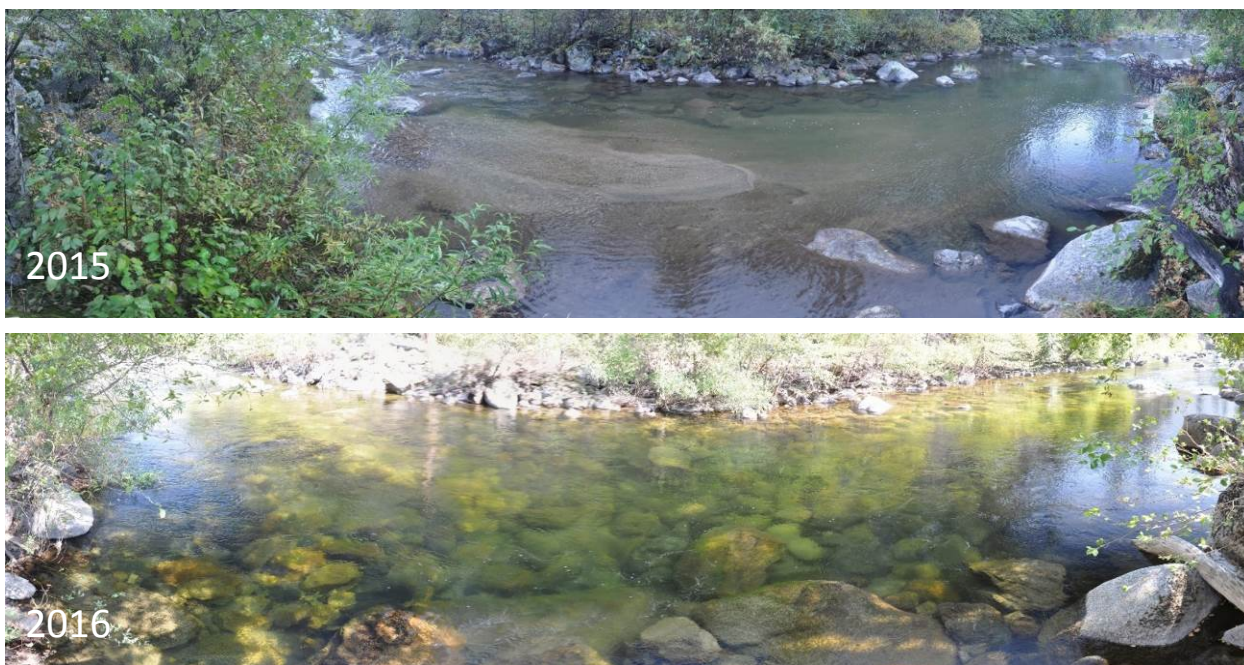
Figure 21. Photopoint 1534+75 comparison between 2015 and 2016 at Driftwood Bar upstream of Albino Rock. The 7,200 cfs OSD release in May 2016 completely scoured Driftwood Bar and removed all plants that were sampled in fall 2015. Similar to other bars formed from sediment deltas, some 3-year-old alders remained in the zone of previously established plants, but the bar itself was gone.

The delta that forms Driftwood Bar comes into the mainstem channel on the right bank at longitudinal station 1535+10. The pool complex ends in the riffle that drops into the Albino Rock study site downstream. The observed deposition patterns were highly localized with minimal sand deposition observed downstream (Figure 21). The 7,200 cfs streamflow completely scoured Driftwood Bar and removed all plants that were sampled in October 2015. The bar area was 2,000 ft² in 2015 and 0 ft² in 2016. Similar to other bars formed from sediment deltas, some 3 year-old alders remained in the zone of previously established plants, but the bar itself was gone.

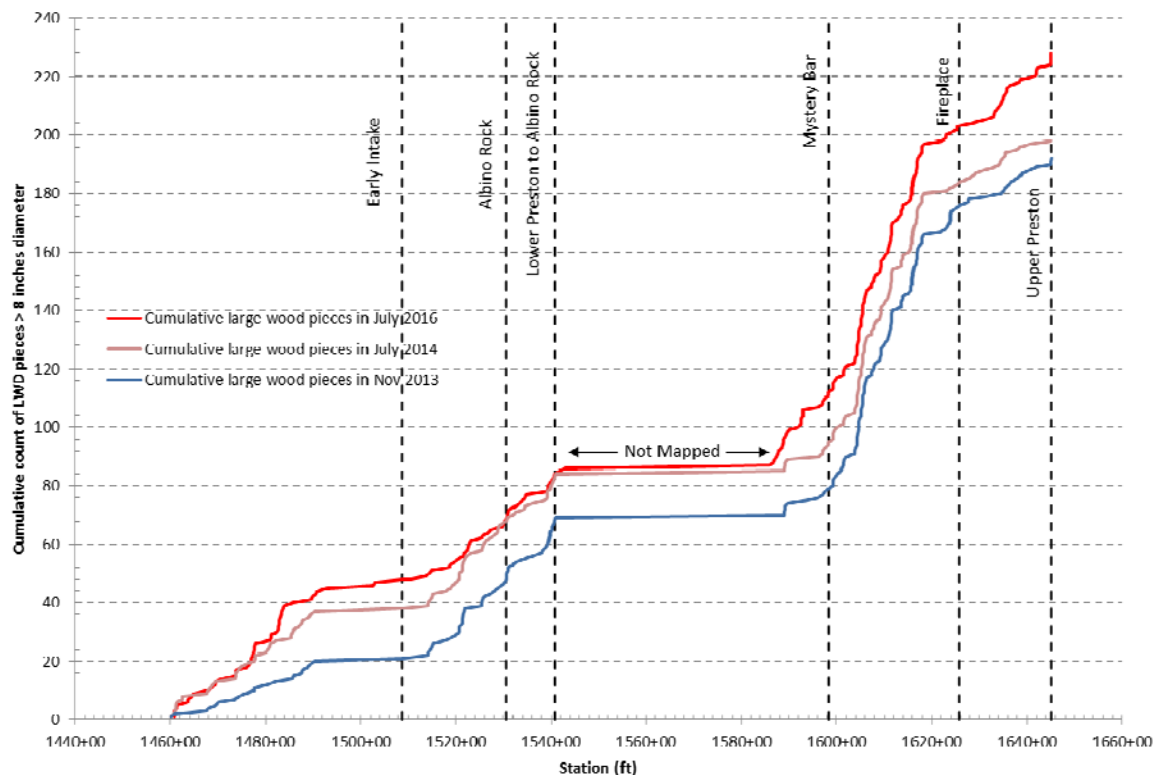
Figure 22. Cumulative count of large wood pieces by longitudinal stationing, showing comparison between winter 2013 and summer 2014 and 2016.

Each mapped piece of wood was assigned a longitudinal stationing and the cumulative number of pieces was plotted through the three subreaches and compared between years (Figure 22). An evaluation of whether large wood storage in the active channel is increasing, decreasing, or being maintained was conducted for each subreach between fall 2013 and summer 2016 (Table 4). The Early Intake subreach had the greatest increase in large wood loading. The decrease of large wood pieces mapped in the Fireplace subreach was likely due to the decrease in water clarity within the deep backwater. Overall, the increase of wood loading between winter 2013 and summer 2016 mapping efforts was 36 pieces. Large wood storage increased in the mapped reaches from 27.8 pieces/mi in 2013 to 32.9 pieces/mi in 2016.
